Table 6-5. Disposal Sites at Camp Lejeune Complex\* (Continued Page 3 of 5)

\* Site Nos. 1-69 and 73-76 are shown on Figure 2-1; Site Nos. 70-72 are shown on Figure 6-36.  
 \*\* Sites recommended for Confirmation Studies.

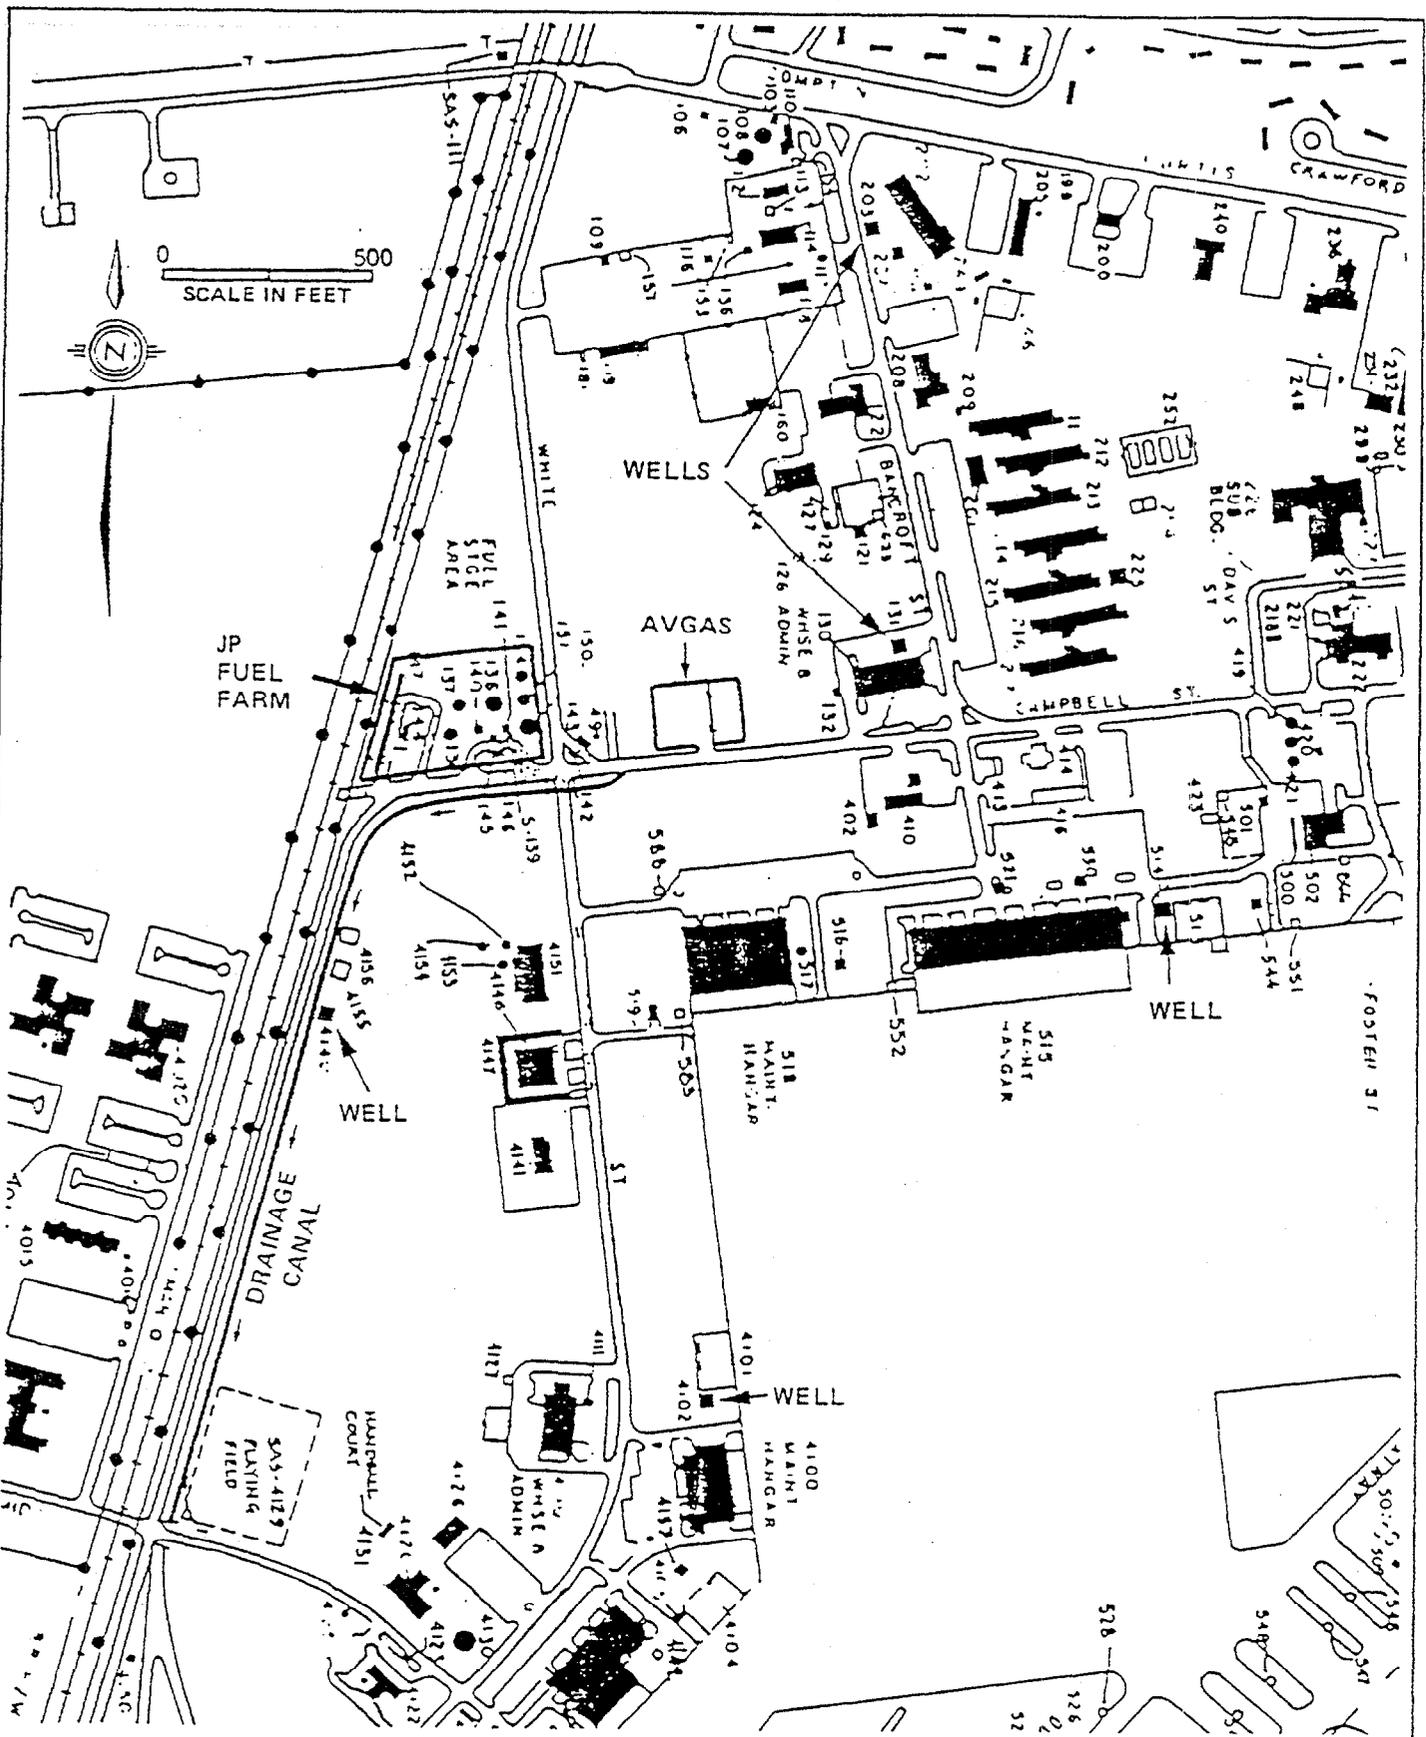
FIGURE 6-24

Activity: Underground tank (or tanks) leaked at the fuel storage area during 1978. At the JP Fuel Farm, extensive leakage from underground connecting lines was discovered in about 1981. Southeastern one-third of area (i.e., approximately 2 acres) is generally affected.

Quantity: 200 to 300 gallons of Avgas. Assuming soils overlying groundwater are generally saturated with oil over about 2 acres, about 600,000 gallons of oil may be involved (i.e., using 20-percent porosity and 5 feet to groundwater). Therefore, estimates are that more than 100,000 gallons of JP fuel have leaked.

Comments: These two storage areas are close together and are considered as one site. Most recent leaks were JP-4 and JP-5 from underground pipes. These pipes have been replaced by an above-ground system in which leaks can be readily detected. An oil-water separator has been installed on the south boundary of the fuel farm, which now shows a substantial amount of oil. Drainage ditch and canal parallel Campbell Street, then flow southward.

Detail of Site No. 45, Campbell Street Underground Avgas Storage and Adjacent JP Fuel Farm

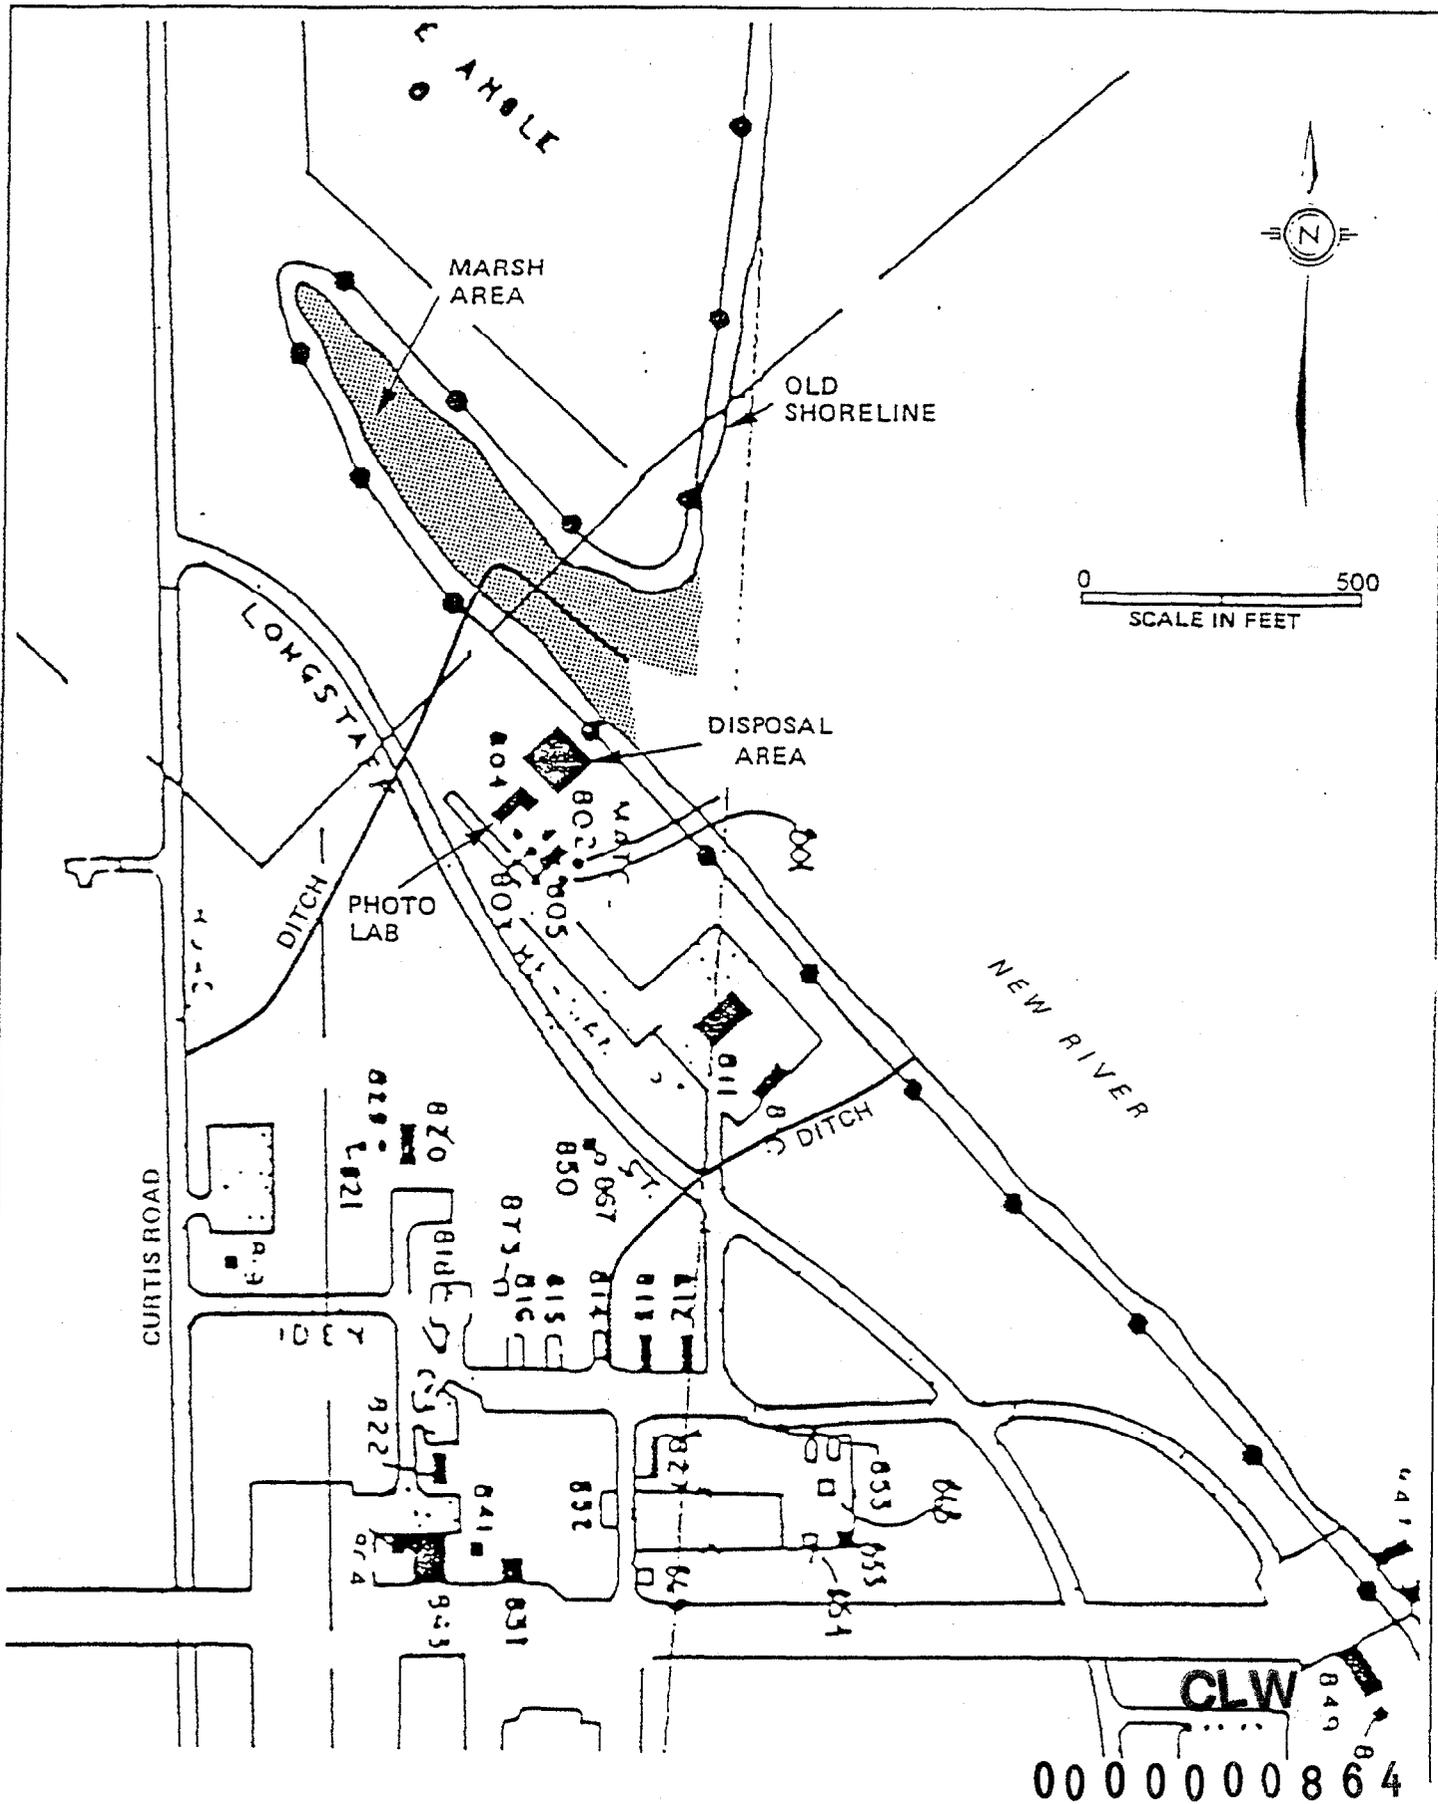
FIGURE 6-26  
 Detail of Site No. 48, MCAS New River Mercury Dump Site

Comments: Best information indicates that material was carried by hand, probably to area between building and river, and dumped or buried in small quantities at randomly selected spots. The solubility of metallic mercury is about 25 ppb, at 25°C, although this may increase due to chloride or hydride complex formation under the proper environmental conditions. The biological transformations of mercury in the aquatic environment (water and sediment) are complex and can enhance bioaccumulation in the food chain. The EPA drinking water standard for mercury is 2 ppb. One thousand pounds (454 kg) of mercury could contaminate about 184,000 acre-feet ( $227 \times 10^6 \text{ m}^3$ ) of water to this level.

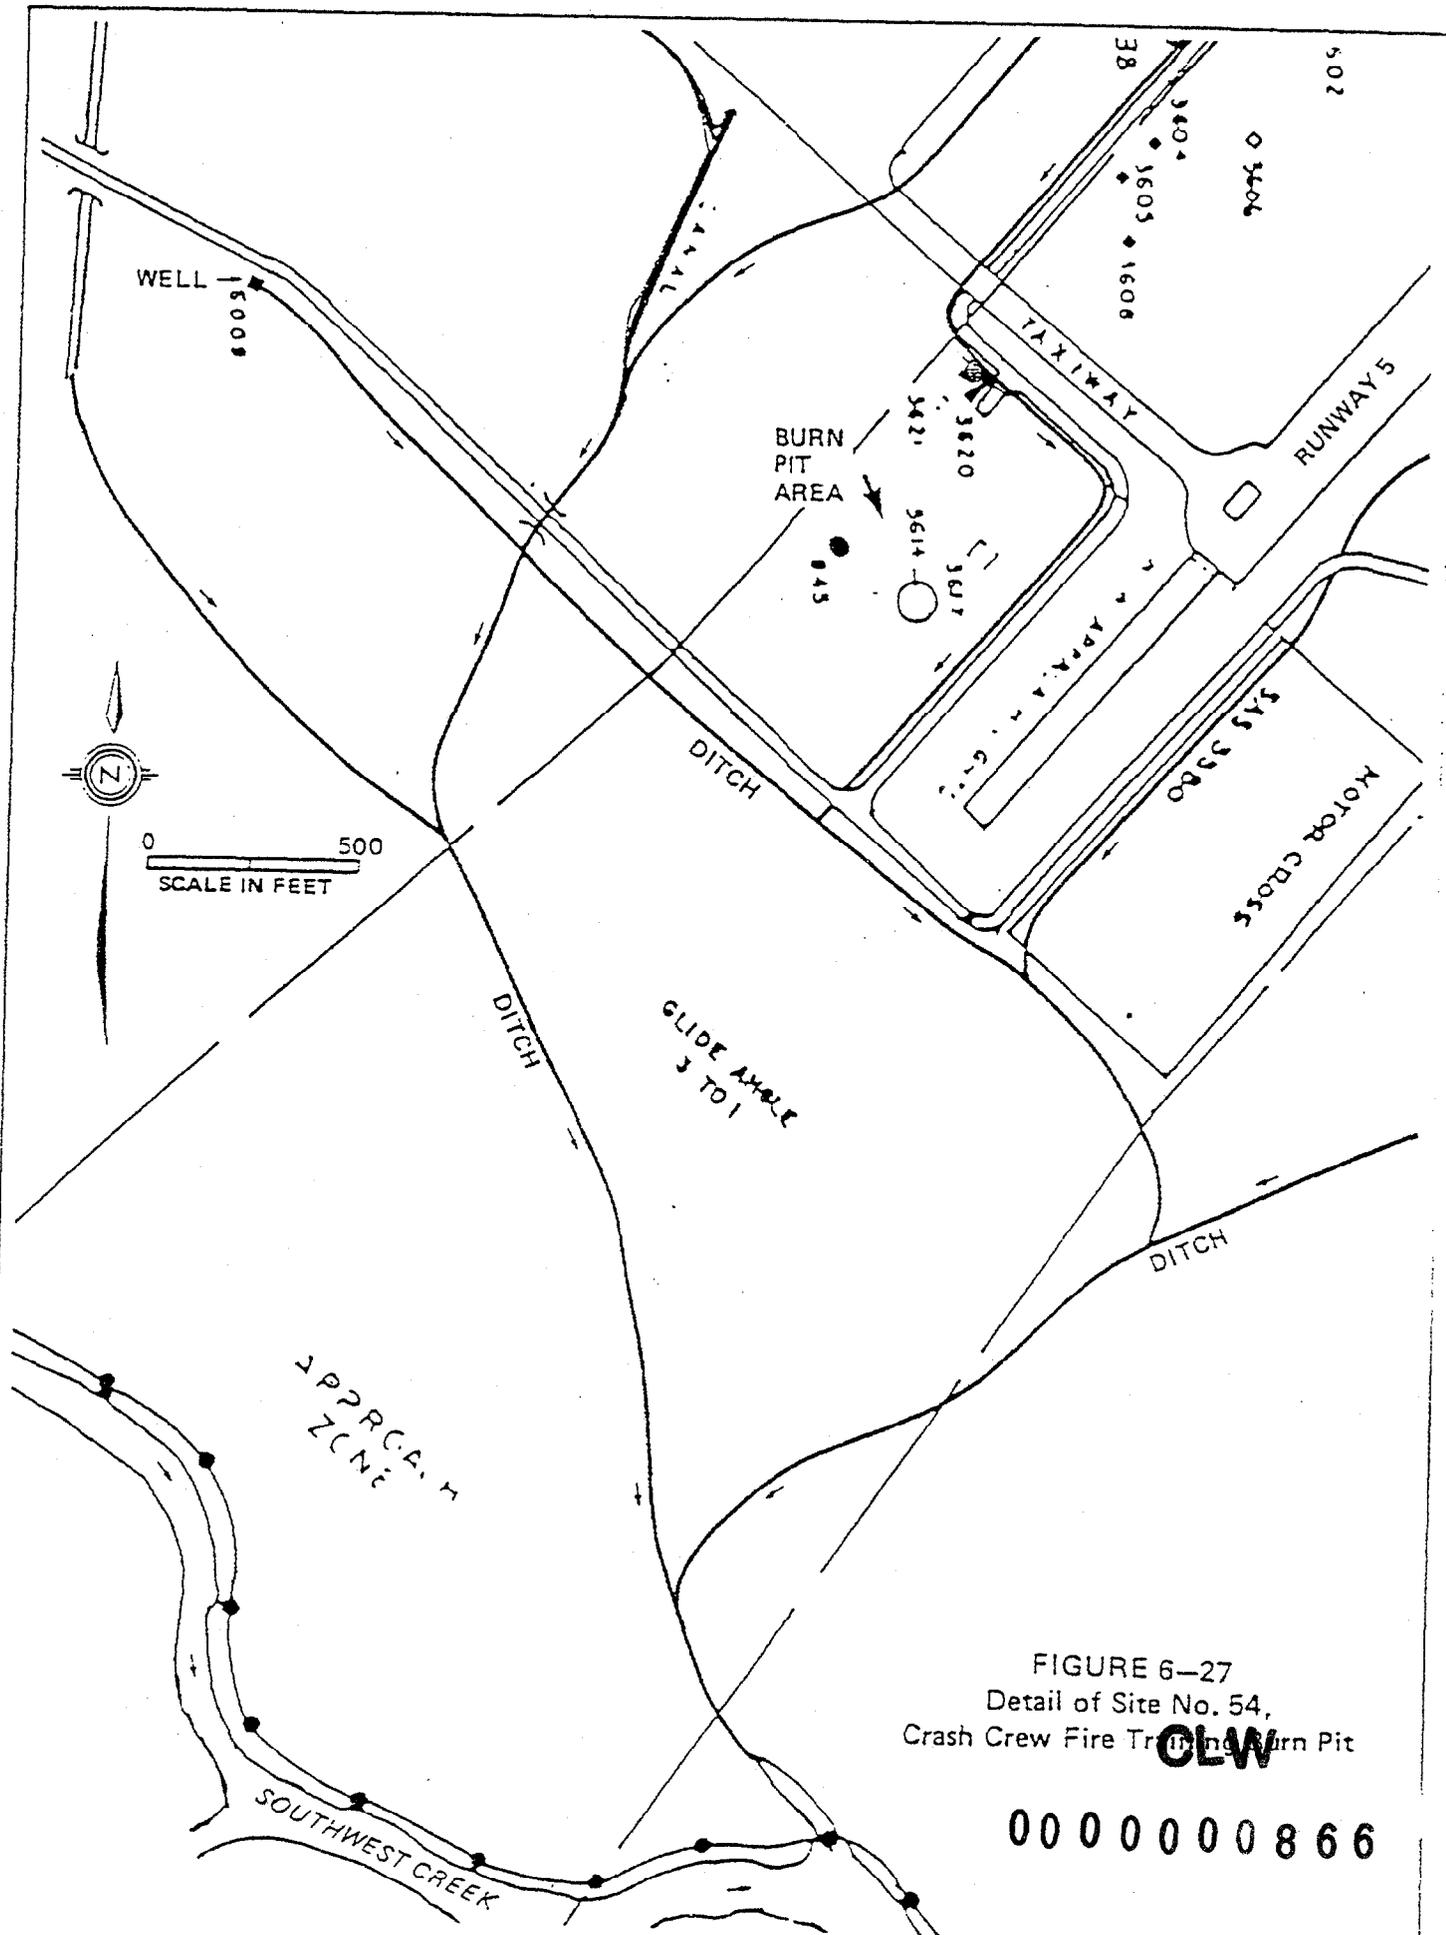
FIGURE 6-27  
 Detail of Site No. 54,  
 Crash Crew Fire Training Burn Pit

Activity: Pit used in crash crew training at air station. Waste oils and solvents were burned.

Quantity: Based on present usage of 15,000 gallons of POL annually, nearly 1/2 million gallons of these compounds have been used at this site. If only 1 percent of solvents and POL soaked into ground before lining, then 3,000 to 4,000 gallons would have entered the soils. Caution: Reliable data have not been found from which to quantify soil contamination. The above estimating procedure is used to provide order of magnitude guidance only.

Comments: Burn pit was lined around 1975. According to some reports, site was used unlined a number of years before this. However, 1964 aerial photographs reveal a very "clean" looking area; no large fuel stains are apparent.

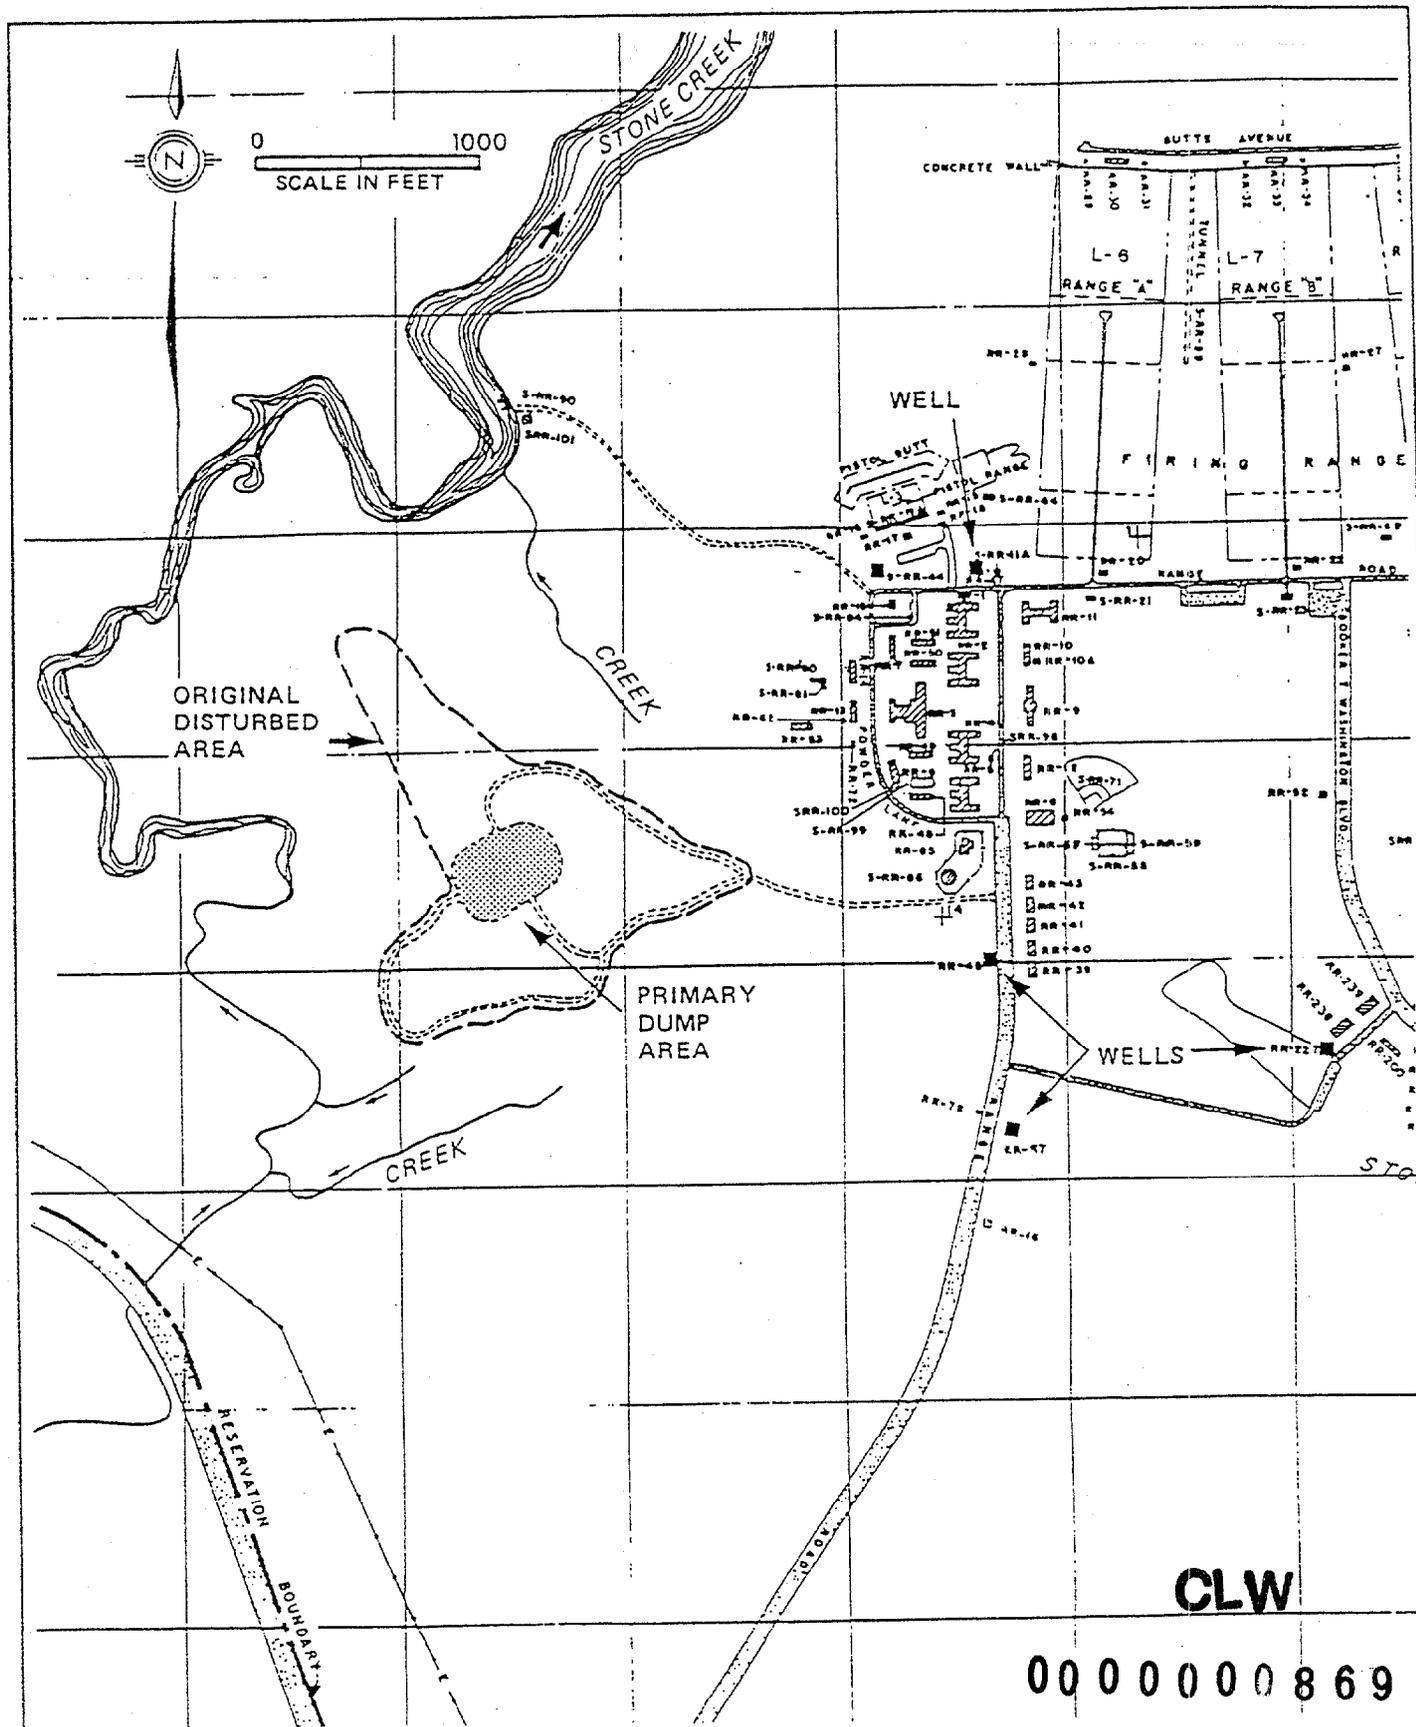
FIGURE 6-29  
Detail of Site No. 68, Rifle Range Dump

Quantity: Using 3 to 4 acres as area and assuming 10 feet of fill, volume is estimated at 50,000 cubic yards. Solvent amounts are estimated to be 1,000 to 2,000 gallons, based on period of use and quantities noted in comments (below).

Comments: Sandy soils in area make site favorable for migration of contaminants. Although site is downgradient from Potable Well Nos. RR-47 and RR-97, heavy pumping may allow contaminants to move upgradient and cause the contamination found in these wells. However, this dump may not be the source of the contamination because total amounts of solvents in the dump cannot be accurately determined.

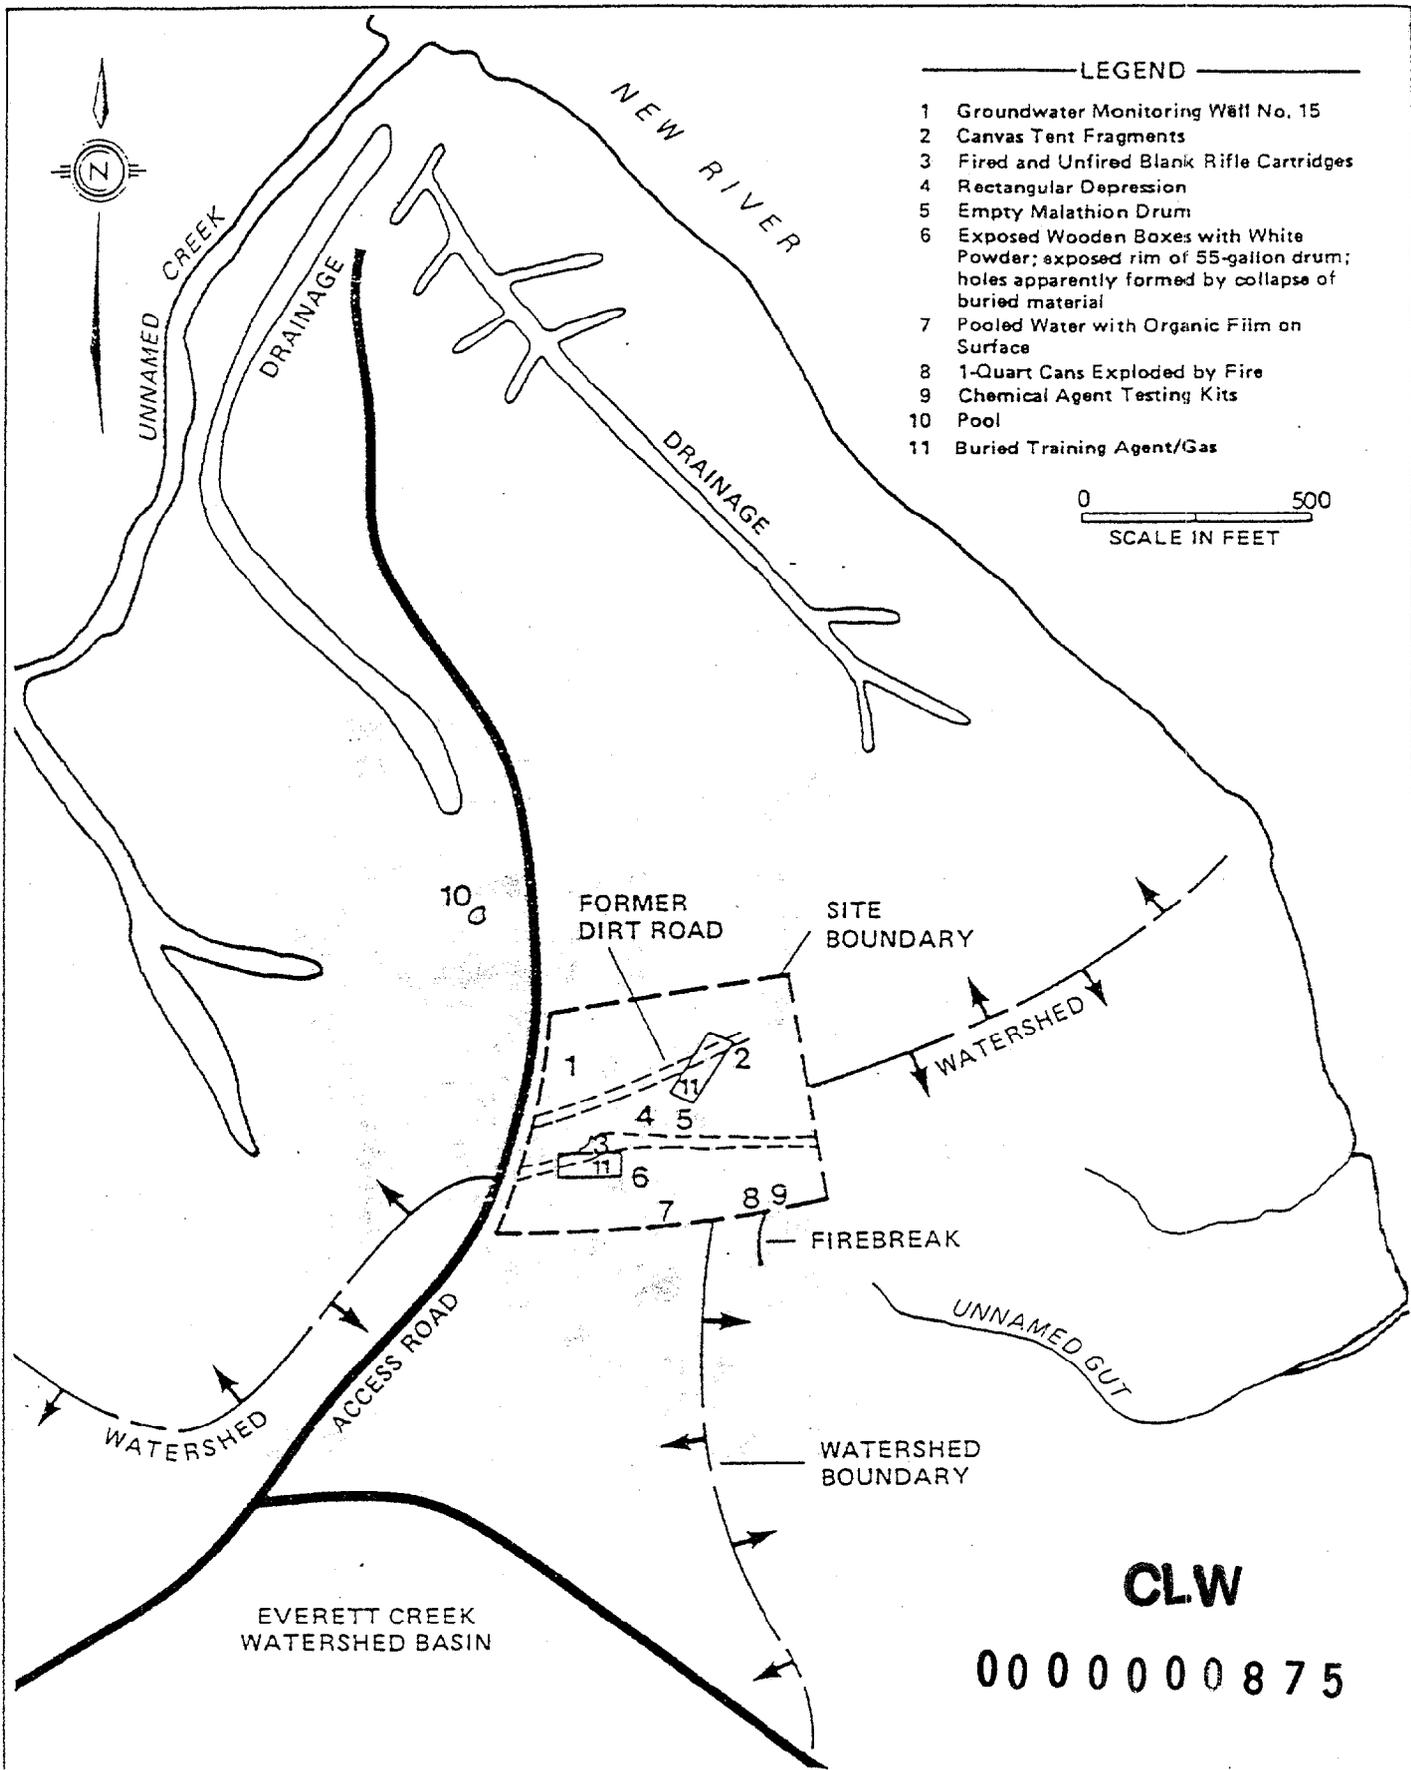
FIGURE 6-32  
Physical Features and Locator Map For Site No. 69

This site is at a higher elevation than surrounding terrain. Subsurface contaminant migration could be in many directions. Groundwater seeps were observed in the surrounding area.

Two reports of atmospheric emissions were noted. One incident occurred possibly as a result of meteorological conditions; the second incident was caused by accidental disturbance of the ground at the site by grading/disking machinery.

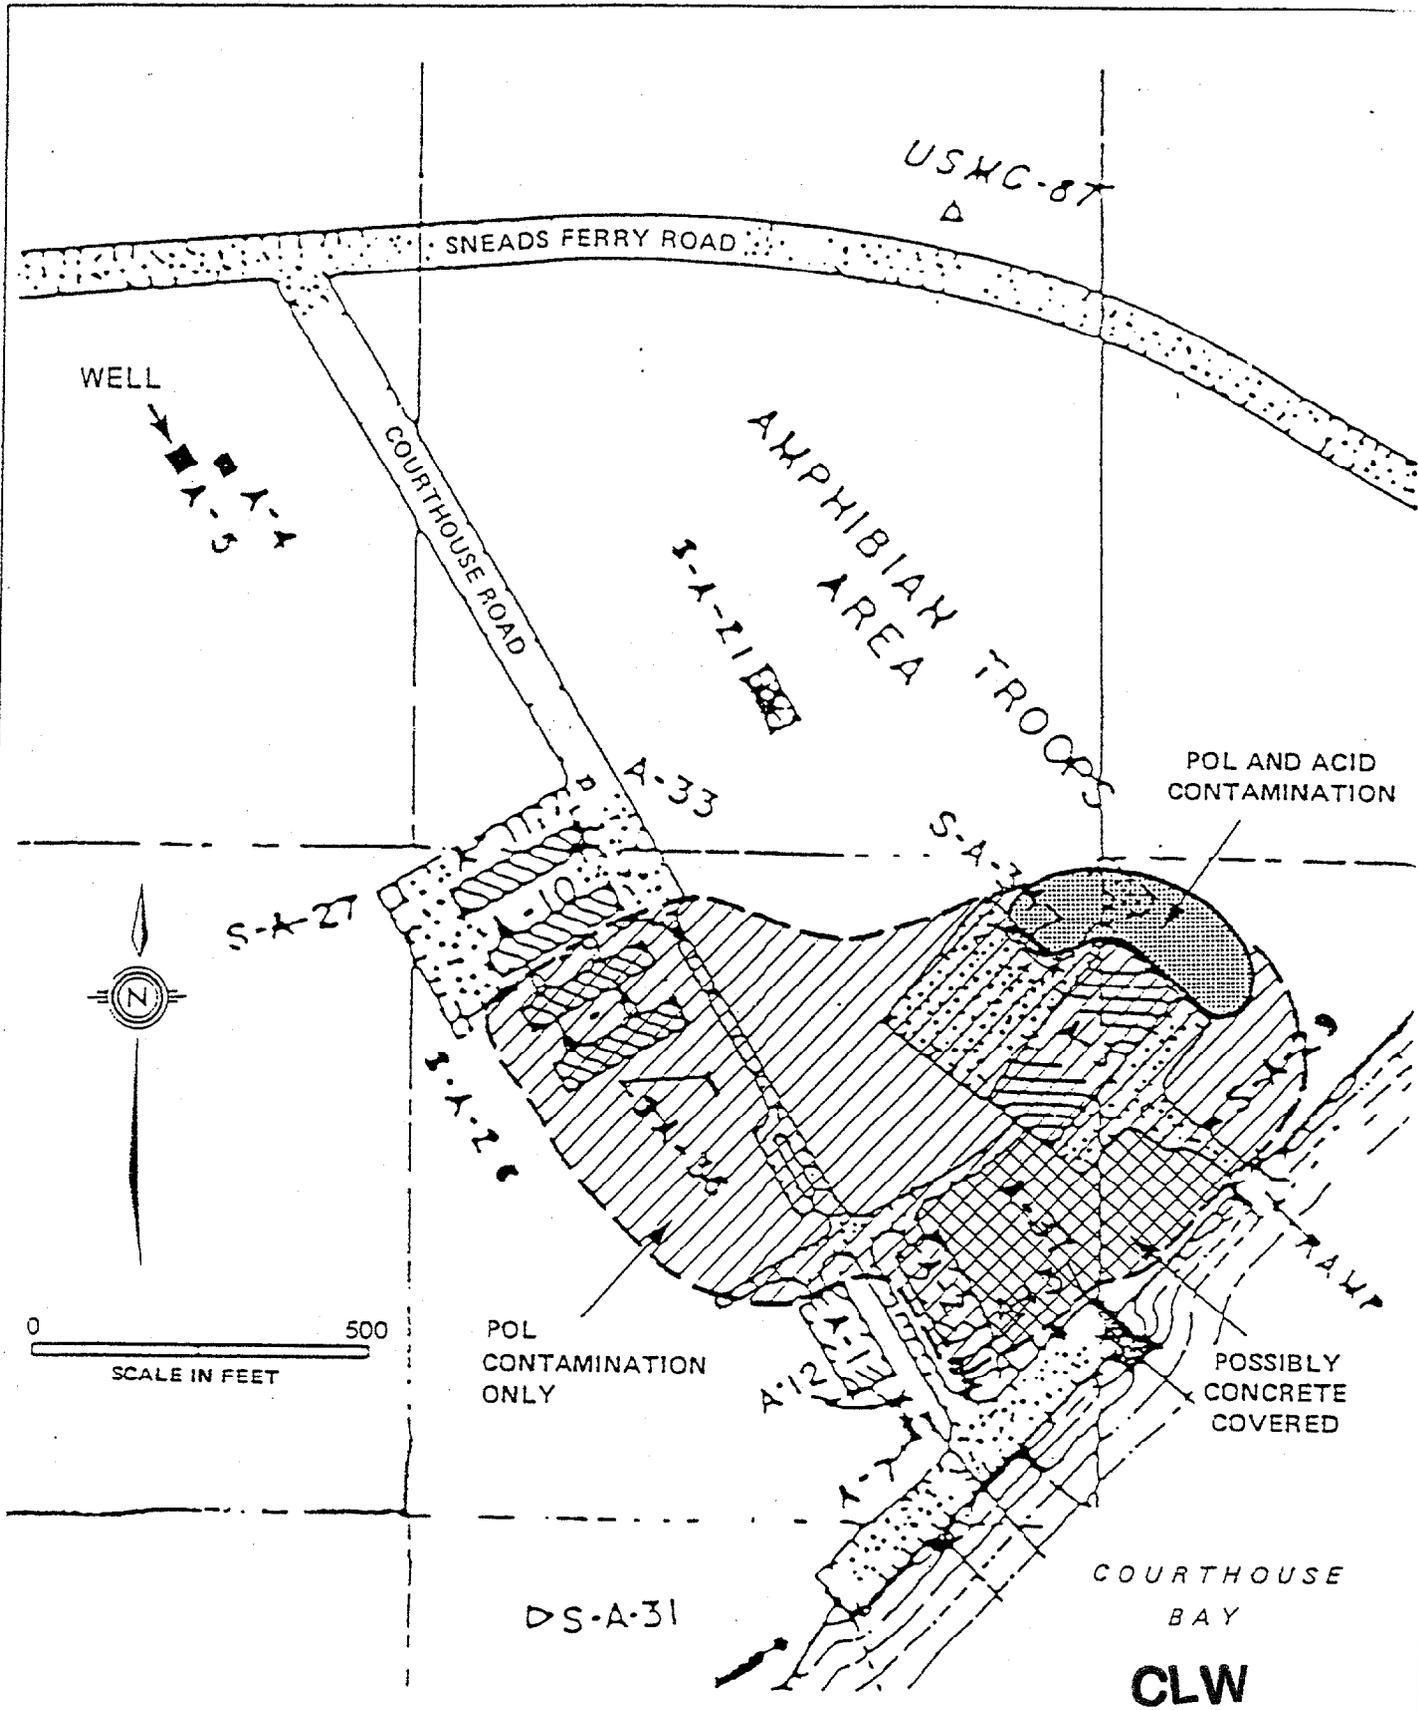
FIGURE 6-34  
Detail of Site No. 73, Courthouse Bay Liquid Disposal Area

The acid disposal area is approximately 200 feet from **CLW** Courthouse Bay. The disposal area for POL only is within just tens of feet from the shoreline.

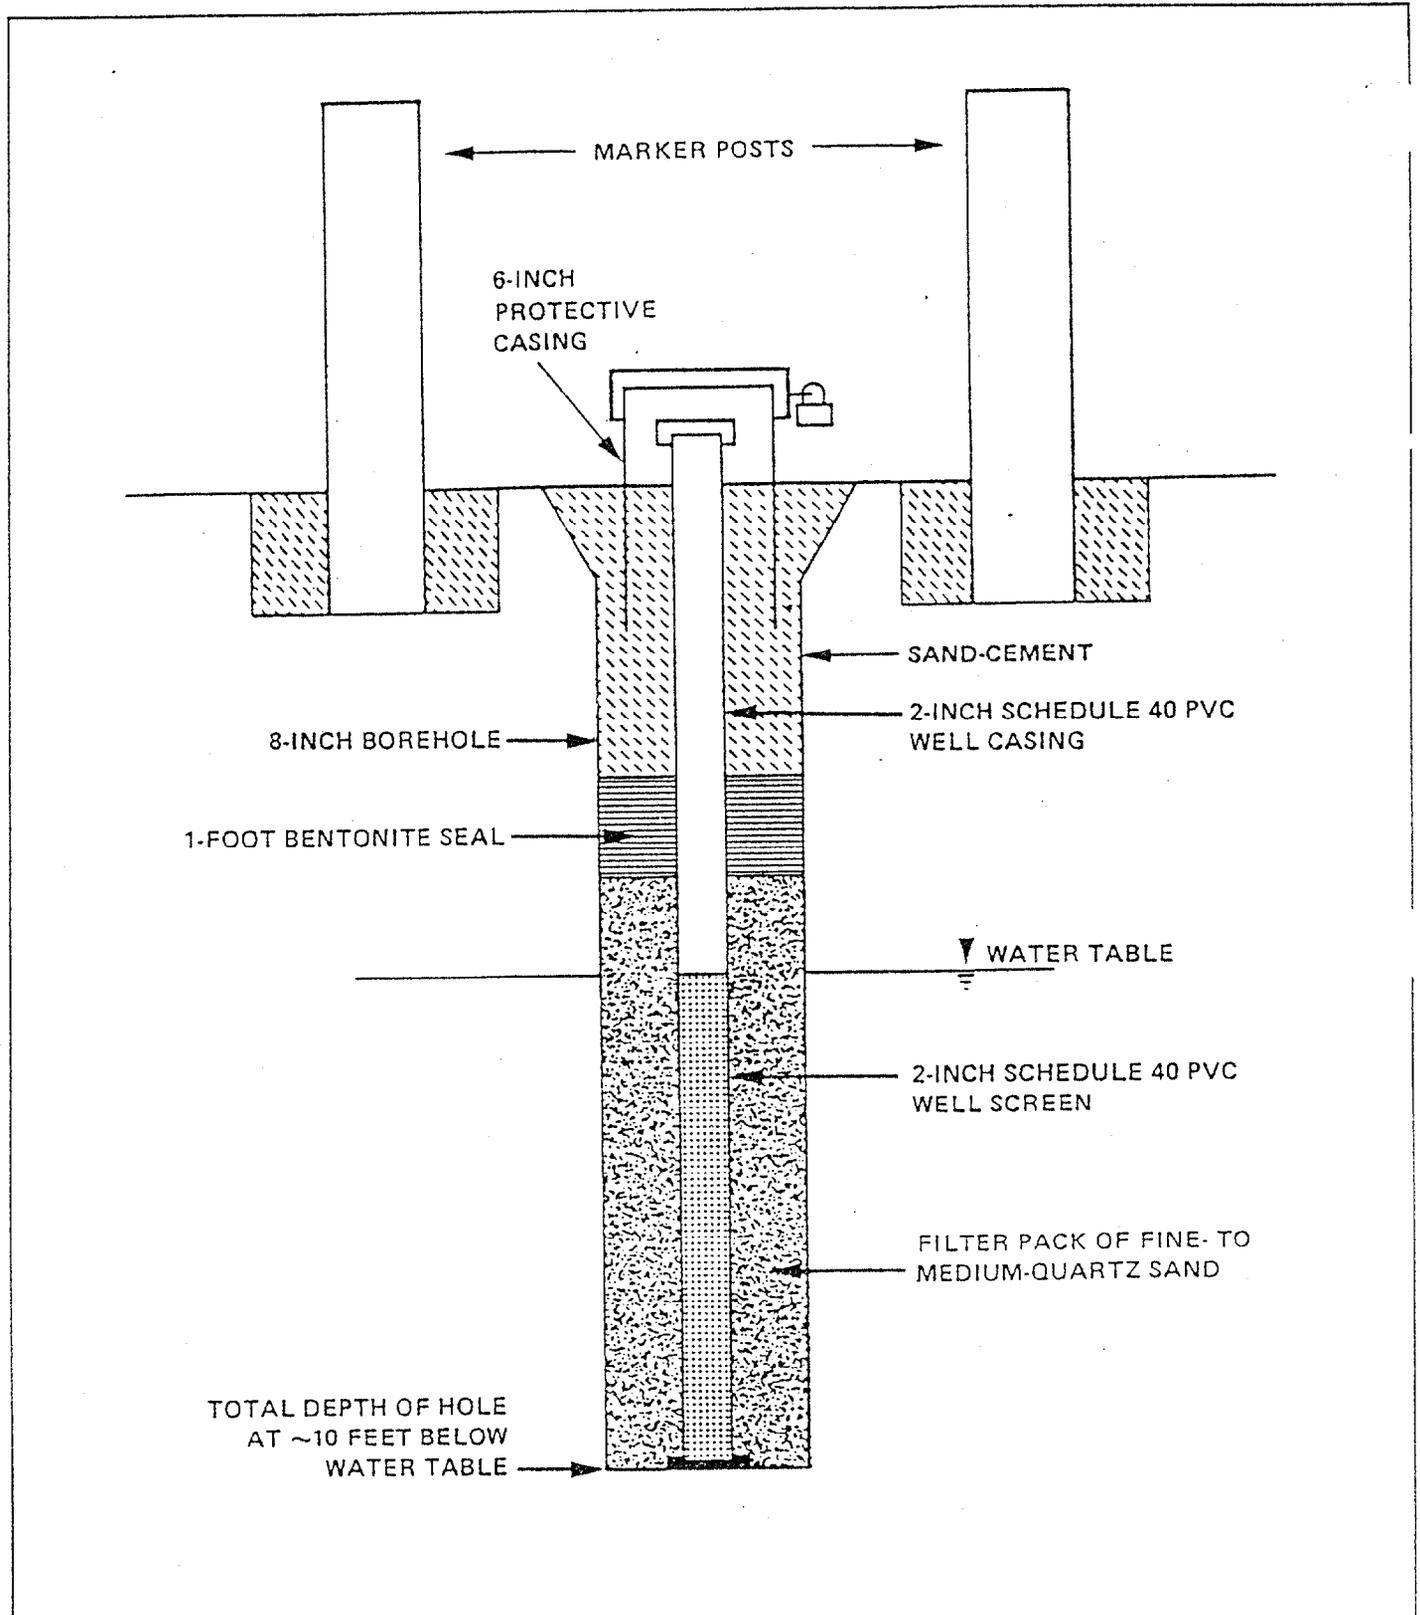
FIGURE A-1. Recommended Monitoring-Well Construction

1. Drill an 8-inch borehole to 10 feet below the water table, as noted during drilling. Collect representative lithologic samples every 5 feet during drilling for preparation of the lithologic log.

2. Install a string of threaded, flush-joint, 2-inch, schedule 40 PVC well casing and well screen. Set the top of a 10-foot length of PVC well screen at the water table if the water table is within approximately 5 feet of land surface. If the water table is encountered at greater depths, some portion of the well screen should be set above the water table. The recommended well-screen slot size is 0.010 inch. The top of the casing should extend approximately 12 to 18 inches above ground level.

The following techniques and materials are recommended to accomplish these two aims (Figure A-1):

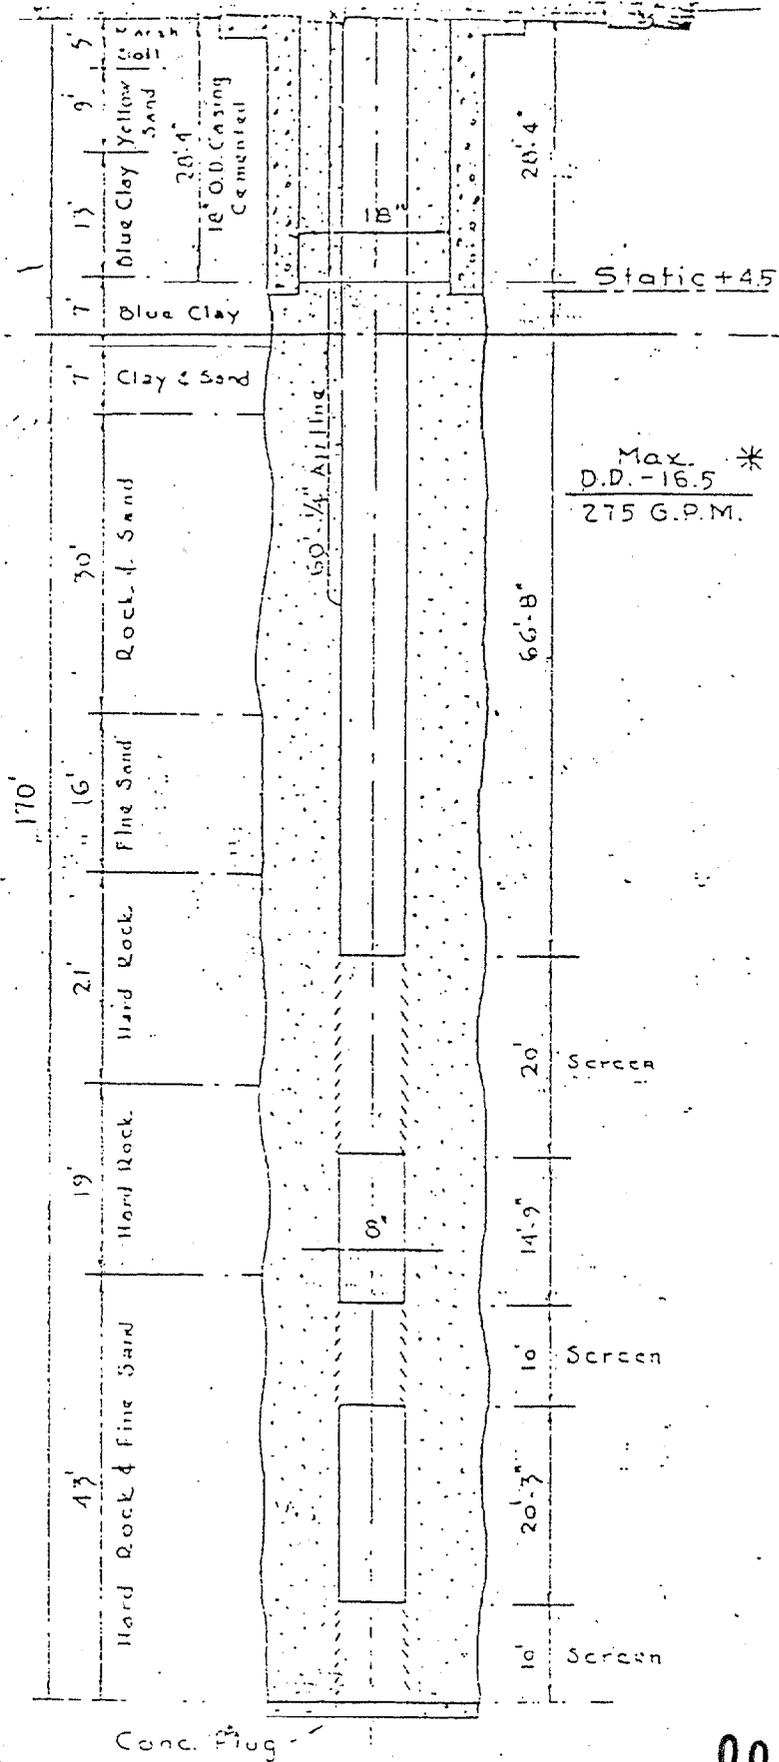
Armco Iron Screen Used In This Well
